**VIRGINIA POLLUTANT DISCHARGE ELIMINATION SYSTEM (VPDES)
MS4 PERMIT**

FORT BELVOIR PCB TMDL ACTION PLAN

U.S. ARMY GARRISON FORT BELVOIR, VIRGINIA

March 2013

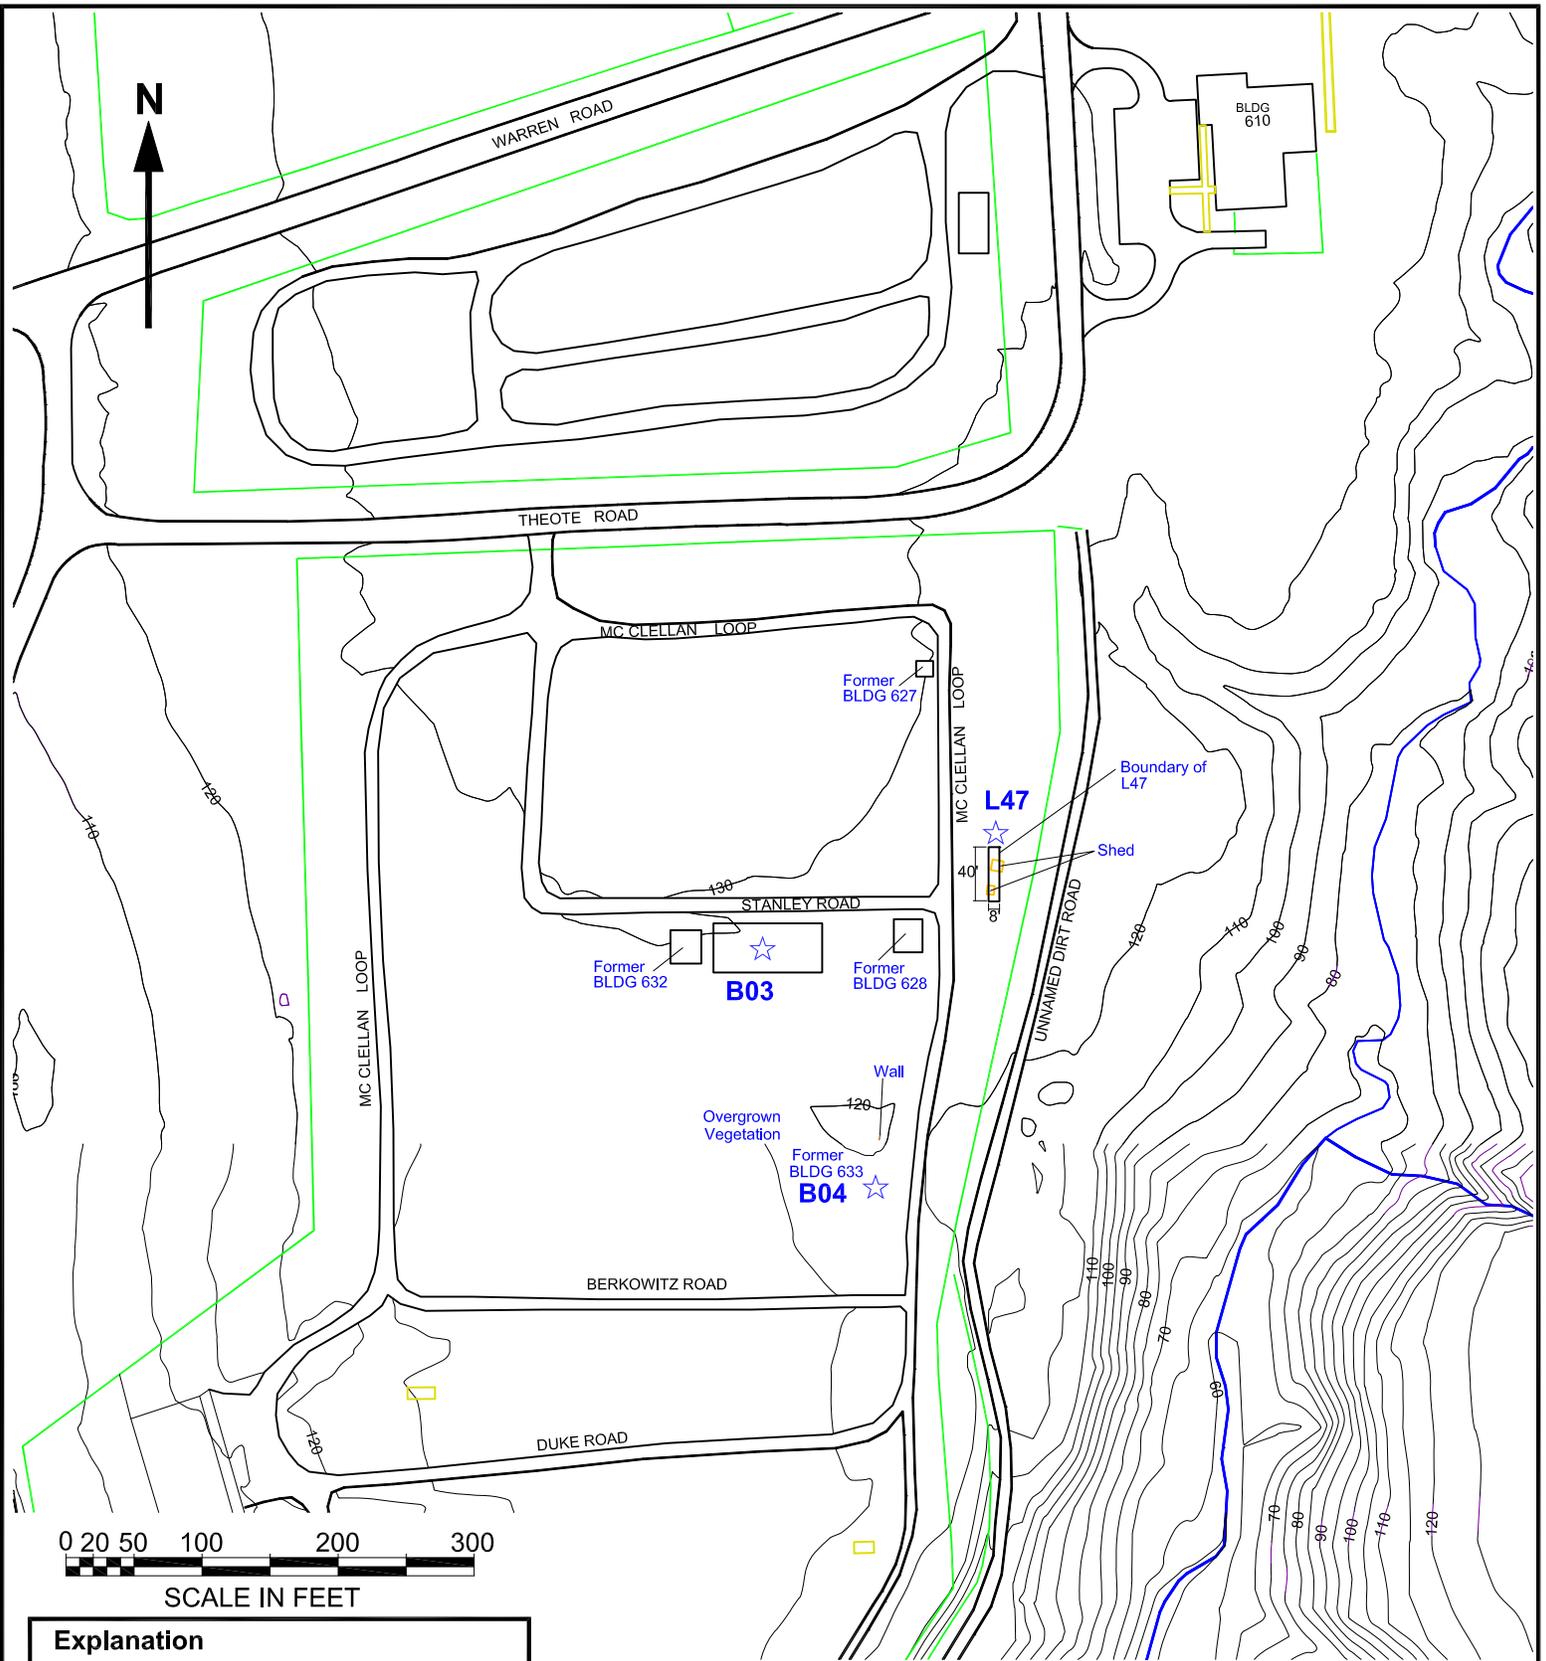
Site L47 was a concrete pad that was used to store transformers until they could be tested for PCBs and then disposed of properly or moved to another storage area as shown in Figure 5. The pad was approximately 40 ft by 8 ft and transformers were noted as being stored on wooden pallets over bare ground to the south of the pad (CH2M Hill, 1992). The pad was located outside and transformers were exposed to precipitation. However, there were no reportable releases. Even though stains on the pad were reported it is unknown whether the staining liquid contained PCBs since the transformers at the site were being held for PCB testing.

The pad has been removed and the site is now wooded with tall grass, medium brush, and young and mature trees. The location of the former concrete pad is shown in Figure 5. This location is on the top of a hill and drains to stormwater swales, to an unnamed tributary that drains to Gunston Cove. Since PCBs are carried primarily by sediment, the thickly wooded nature of the site would reduce the probability for potentially contaminated sediments to travel. It is unlikely L47 would discharge PCBs to impaired water bodies and therefore the site is recommended for No Further Action.

Conclusion: Recommended No Further Action pending PCB sampling results from Phase I RFI and final site determination to be included in 2012-2013 Annual Report.

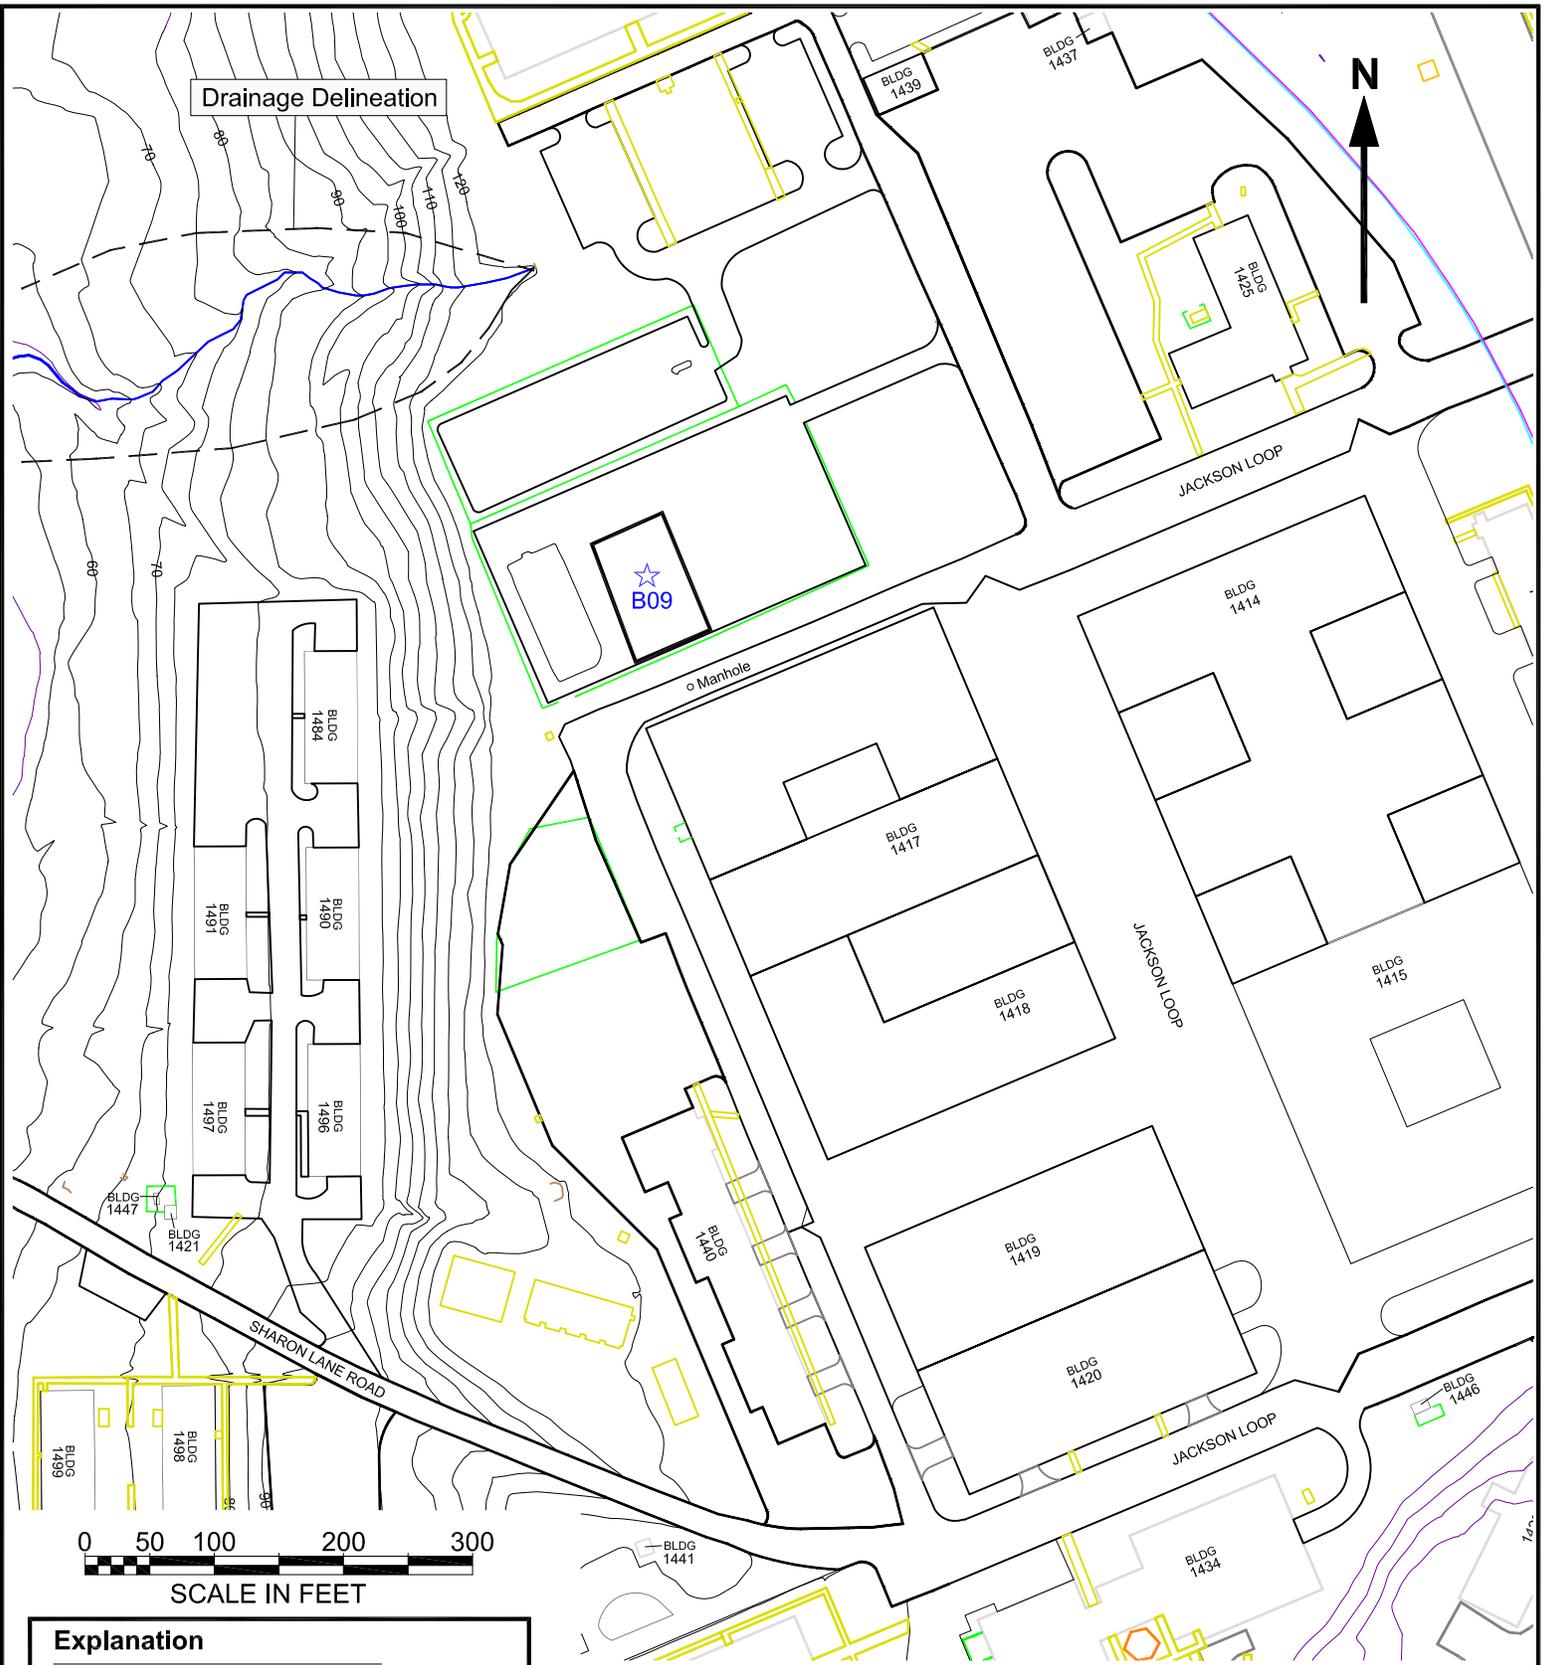
B09 was a former transformer storage area located at Building 1430 as shown in Figure 6. Transformers were stored both indoors and outdoors at this site. Building 1430 no longer exists and the area where the building once stood is now used as a storage area for trailers and large generators. Soil samples and wipe samples were collected in 1997 in accordance with the SWMU corrective action closure plan. The data summary is in Table A-6, Appendix A. All results were non-detect for PCBs, leading to the conclusion that the site had not been impacted and should be recommended for closure (Fort Belvoir DPW ENRD, 2012). Figure 6 shows the location of B09.

While transformers containing PCBs were stored at B09, secondary contaminant was present. Prior to 1991, secondary containment consisted of two metals pans where the transformers were stored. In 1991, the metals pans were replaced with the installation of secondary containment consisting of a concrete berm and sealed floor. Even though leaks were observed at the site, there is no indication that the environment was negatively impacted by PCBs due to the secondary containment. The area is fully paved and while there are no direct drainage swales, the closest stream that is approximately 40 ft to the north-northwest, is an unnamed tributary that flows to Accotink Creek. The absence of PCBs at the site and lack of direct drainage leads to the conclusion that it is unlikely B09 would discharge PCBs to impaired water bodies.

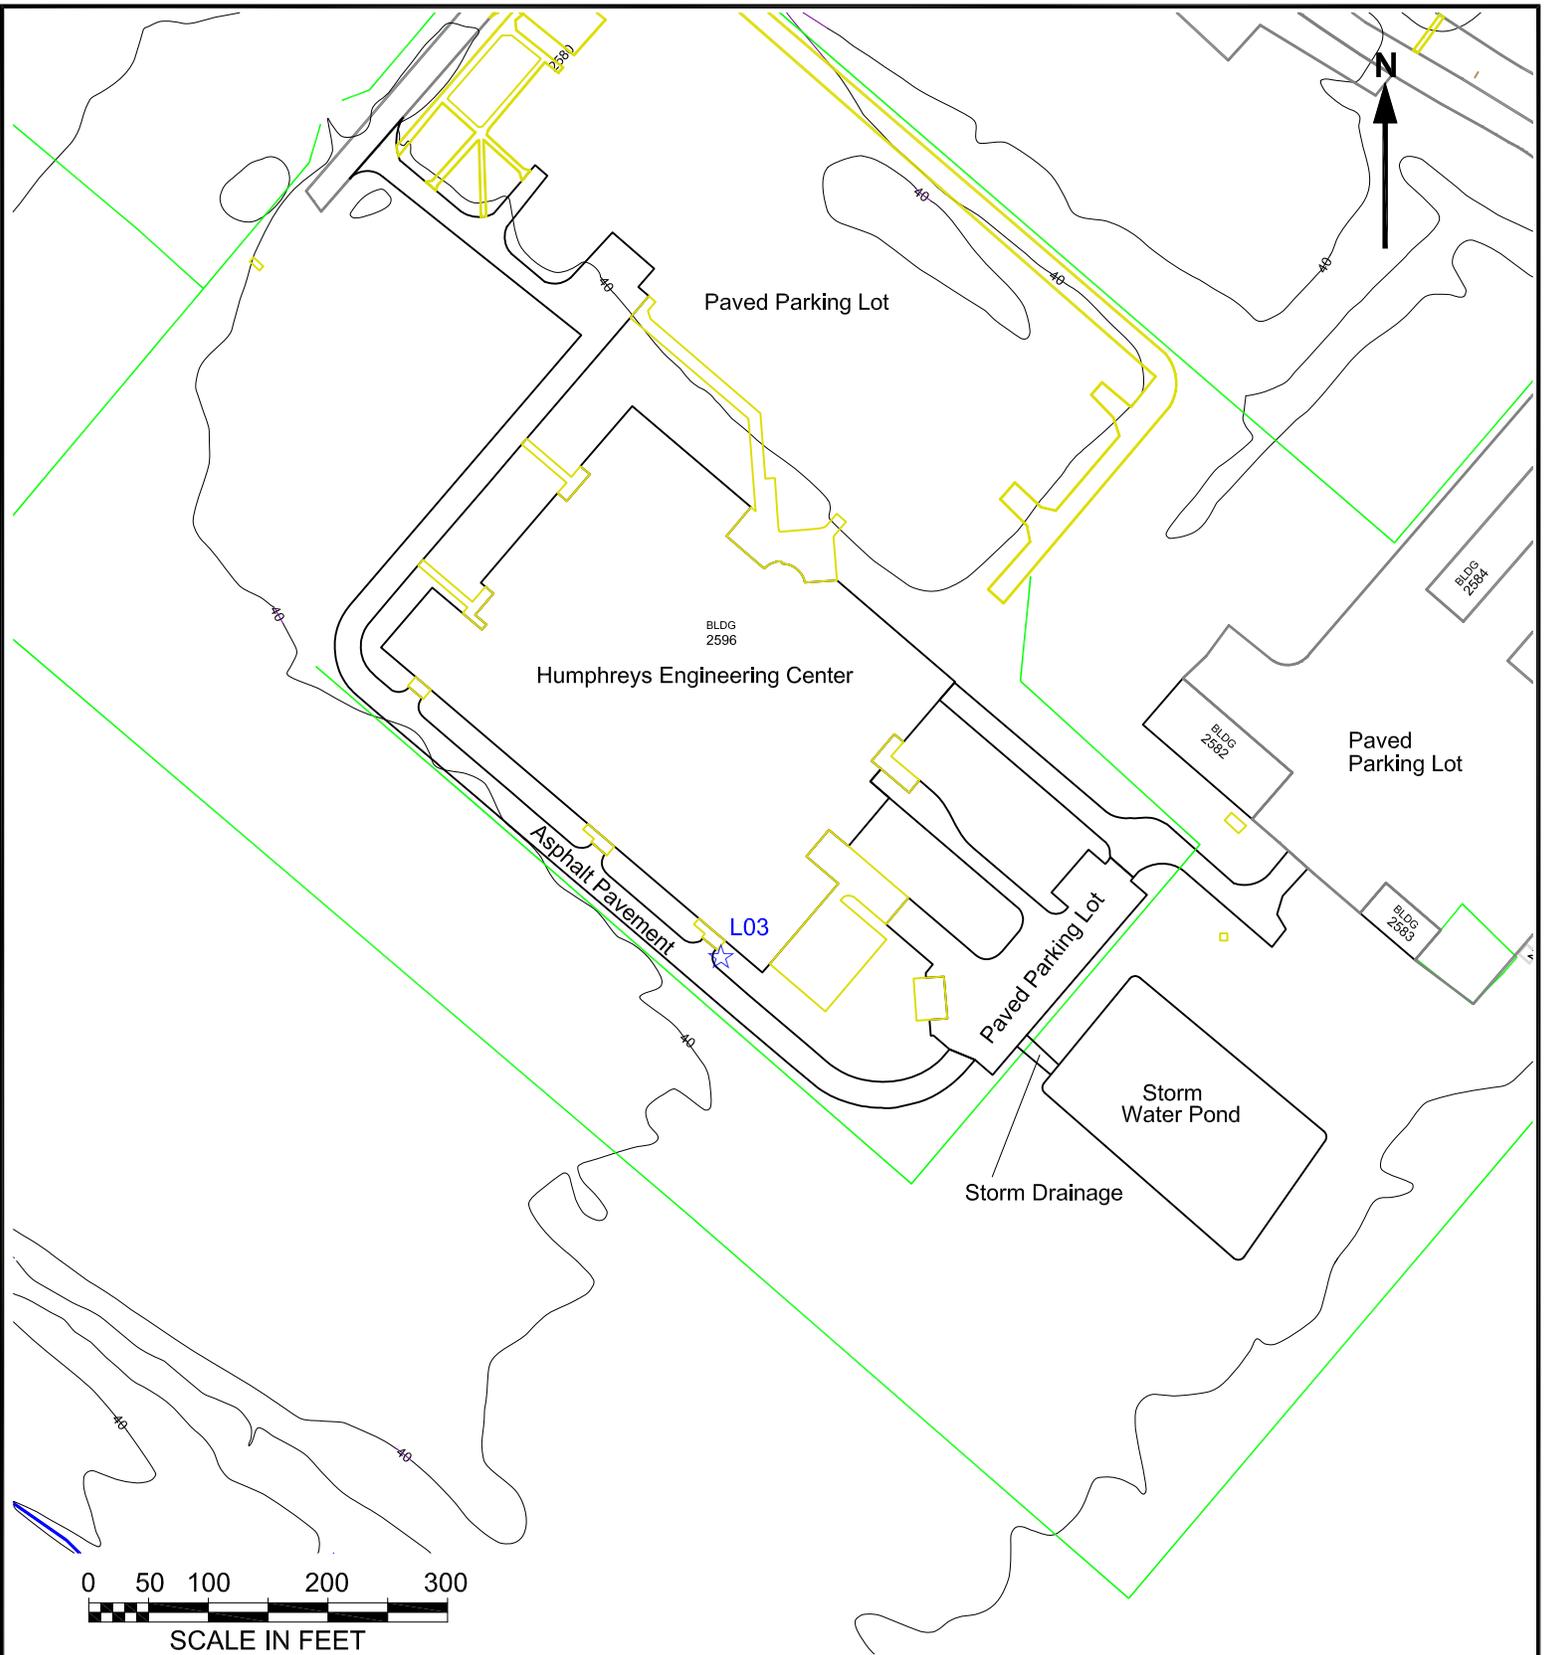
L03 was not considered as an official PCB storage area. In 1988, transformers were reported as being located at the site and the presence of fluid staining the asphalt was noted (Kearney, 1988). However, no known sampling occurred at the site and there is no documentation of PCB contamination at the site as presented in Figure 8.

The area that was once the asphalt pad has been demolished and redeveloped as part of a parking lot for Humphreys Engineering Center. This area would drain to stormwater swales, to an unnamed tributary, to the wetlands in Jackson Miles Abbott Wetland Refuge, to Mulligan Pond, and to Dogue Creek. It is unlikely the area described by L03 would discharge PCBs to impaired water bodies and therefore the site is recommended for No Further Action.

Conclusion: Recommended No Further Action pending PCB sampling results from Phase I investigation and final site determination to be included in 2012-2013 Annual Report.

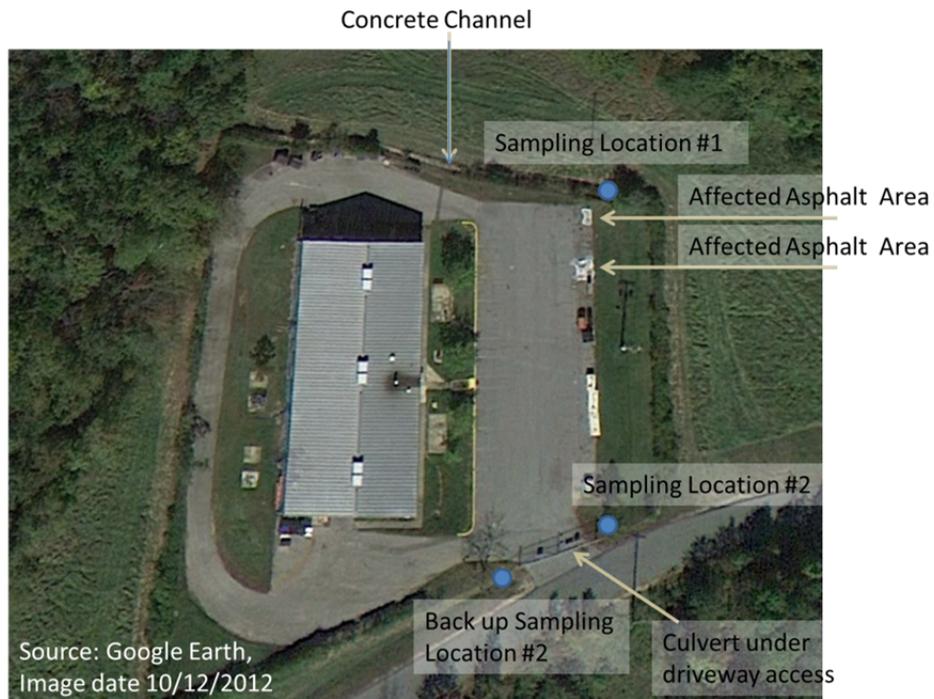
Conclusion: Characterization stormwater sampling required

Recommended Sampling Locations: Two stormwater sampling locations are recommended at the Building 1495 site. The first location (#1) is north of the affected asphalt area at the beginning of the concrete channel that runs along the northern border of the property. Location #1 is located outside of the fenced area. The second location (#2) is south of the affected asphalt area just before the entrance to the culvert running under the access driveway to the parking lot. A backup sampling location at the exit of the culvert was also designated for location #2 since the culvert entrance is located behind the access fence and may result in access problem. The exit of the culvert is outside of the fenced area. The recommended sampling locations are shown on the aerial view of the site below.
