RE: Virginia Pollutant Discharge Elimination System (VPDES) MS4 Registration No. VAR040093
U.S. Army – Fort Belvoir
Local TMDL Action Plan Approval

- Final, Virginia Pollutant Discharge Elimination System (VPDES) MS4 Permit, Fort Belvoir PCB TMDL Action Plan at U.S. Army Garrison Fort Belvoir, Virginia, dated March 2013

FINAL

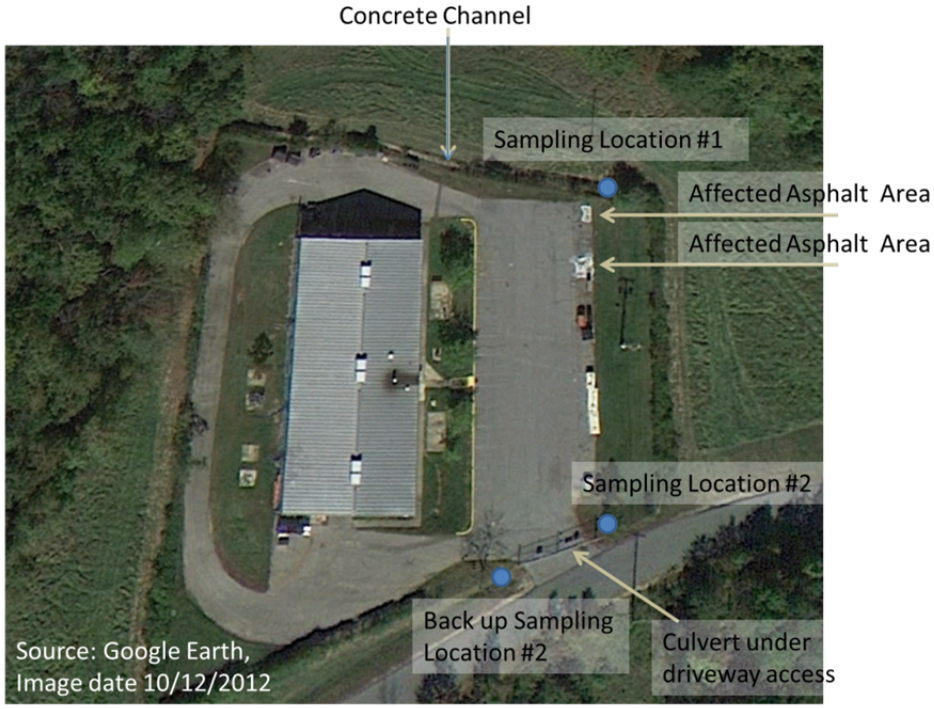
Conclusion: Characterization stormwater sampling required

Recommended Sampling Locations: Two stormwater sampling locations are recommended at the Building 1495 site. The first location (#1) is north of the affected asphalt area at the beginning of the concrete channel that runs along the northern border of the property. Location #1 is located outside of the fenced area. The second location (#2) is south of the affected asphalt area just before the entrance to the culvert running under the access driveway to the parking lot. A backup sampling location at the exit of the culvert was also designated for location #2 since the culvert entrance is located behind the access fence and may results in access problem. The exit of the culvert is outside of the fenced area. The recommended sampling locations are shown on the aerial view of the site below.
