Stormwater Management Facility Corrective Action Plan

U.S. Army Garrison, Fort Belvoir
Fort Belvoir, Virginia
VPDES Permit No. VAR040093
Contract No. GS-10F-078AA
Delivery Order No. W91236-13-F-0048

Prepared by:
Stantec Consulting Services Inc.
(formerly WEG, Inc.)
150 Riverside Parkway, Suite 301
Fredericksburg, Virginia 22406
(540) 785-5544
(540) 785-1742

May 19, 2014

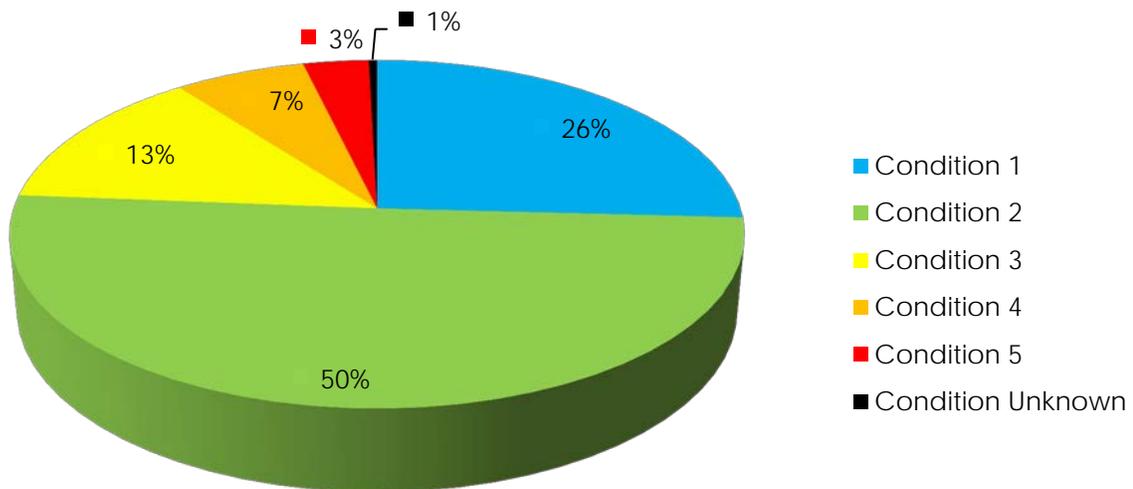
Summary of BMPs by Rating Condition

As summarized in the pie chart below, 62 of the 241 BMPs (26%) inspected in 2014 were rated as Condition 1, fully functional. A total of 153 BMPs (63%) were rated as Condition 2 or 3, operating effectively but with minor defects or deterioration that need to be monitored and/or addressed. Only 16 BMPs (7%) were reported as Condition 4, not operating as designed with major defects to be addressed. Lastly, 8 BMPs (3%) were rated as Condition 5, with major deficiencies requiring near-term attention to correct. It should be noted that one BMP (<1%) was rated "Unknown", as it could not be inspected due to changes in configuration.
